## Long Beach July 2015 Secondary Network Outages RCE

### Summary and Report

## Summary of SCE's Performance Review of the Long Beach July 2015

### Secondary Network Outages

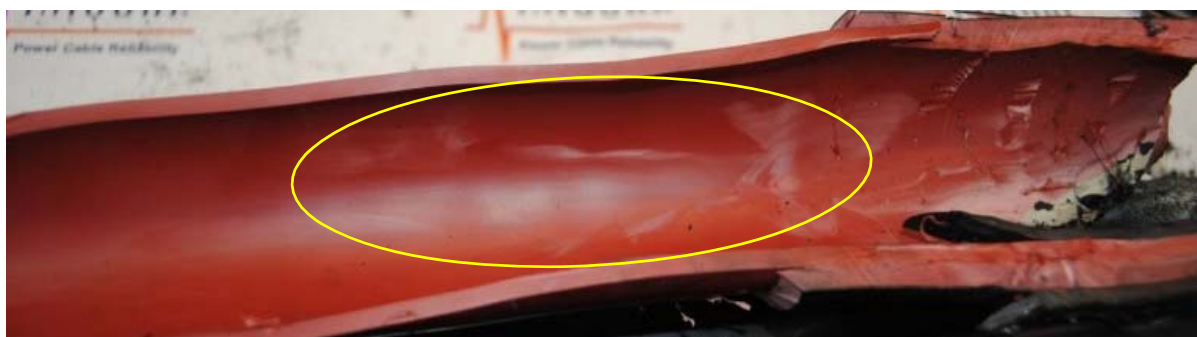
**Figure 4:** Red phase white marks on the red insulating tube indicating likely erosion activity associated partial discharge activity in voids due to insufficient shrinkage. Disregard pry marks from the dissection effort on the right side of the oval.

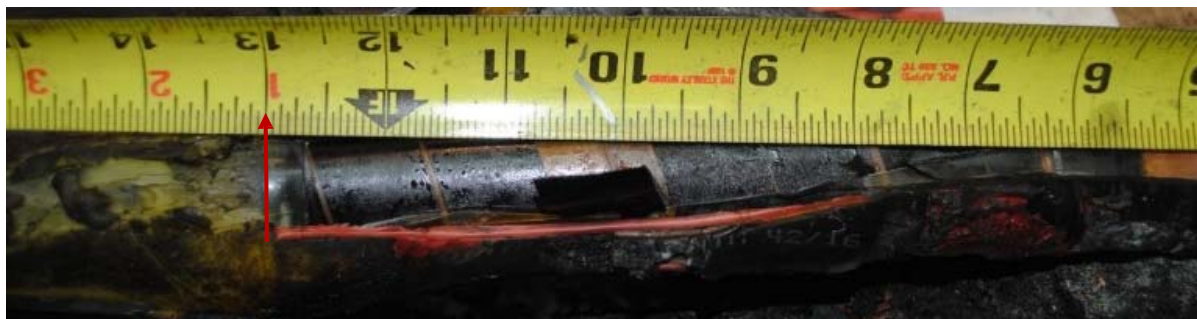
The single most significant risk factor identified on the Steam 12kV cable splice was craftsmanship. The conductive material and paper insulation interface were found to not have been removed from the splice as required by the manufacturer's installation instructions. Failure of the Float splice may have exposed the inherent internal weaknesses on the Steam splice due to craftsmanship. It is indeterminate what the impact of the Steam splice failure was to the overall events.

**Figure 5:** Red phase dimensions of conductive material (black carbon paper tape) layer extending from the lead sheath cutback to near the conductor connector (yellow mastic over connector area starting at about 13 inches). Copper tapes ending approximately at the 6.5 inch mark. Brown insulating paper tape shown below black carbon paper.

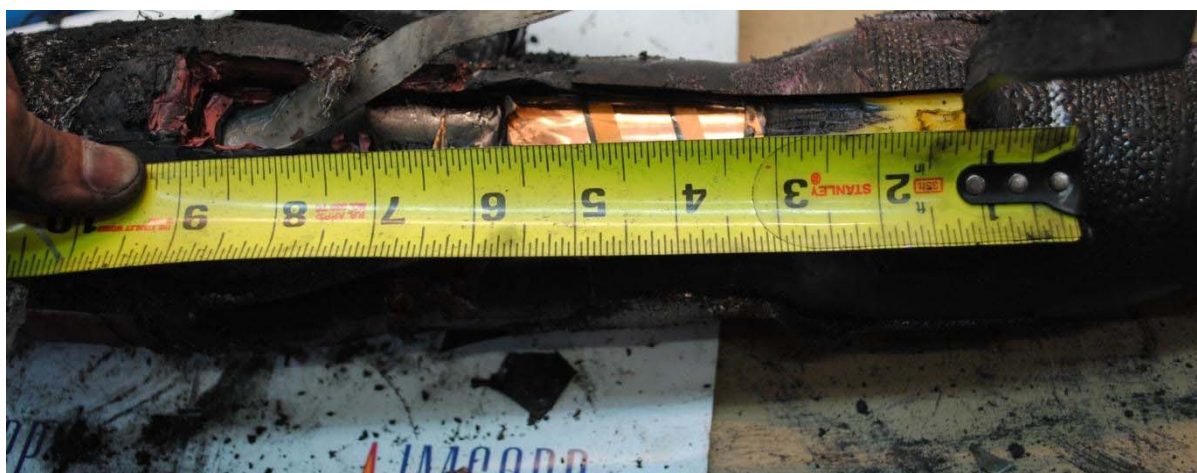
**Figure 7:** Blue phase copper tapes ending at approximately 6.5 inches from the lead sheath cutback reference point (grey mark on jacket). Black carbon paper tape extending well beyond the 6 inch mark heading towards the conductor connector.

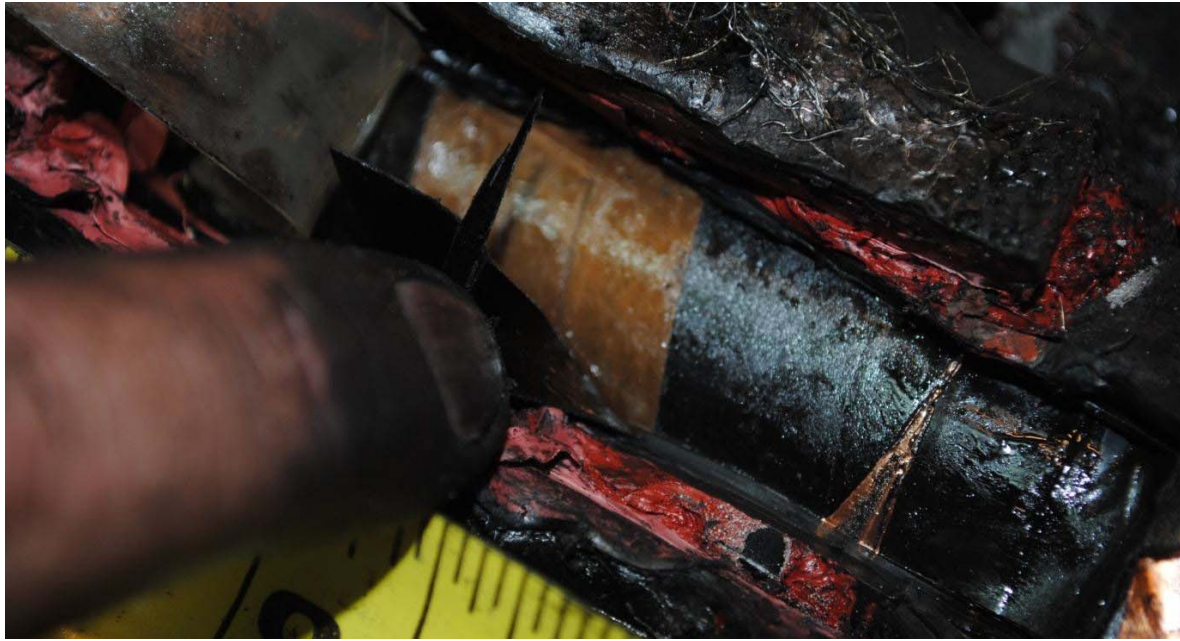
**Figure 8:** Blue phase close up of black carbon paper tape extending well beyond the 6 inch mark heading towards the conductor connector.

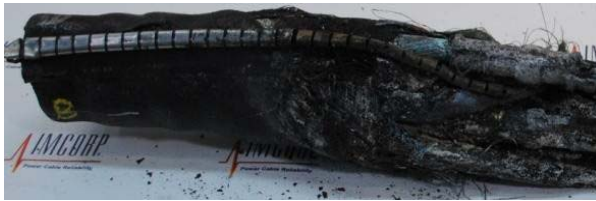
The visual inspection and dissection of the cable splice was conducted and certain risk factors were identified. The damage on the Float splice was significant and the cause of its failure was indeterminate.

**Figure 9:** Float joint as received and unpackaged at IMCORP. Most of the insulating material around the conductor connectors is missing suggesting where the fault may have originated.

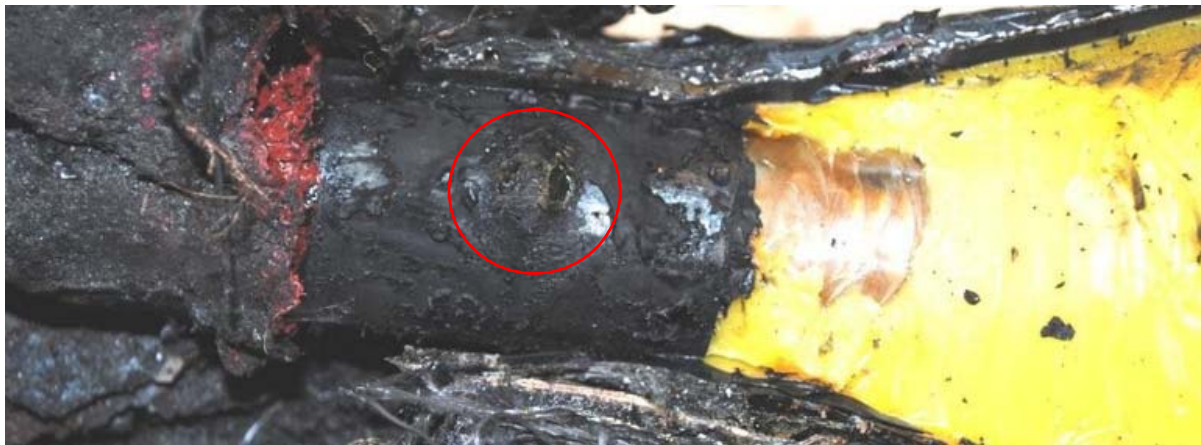
**Figure 10:** Evidence of uneven shrinkage of the oil barrier tube leaving an air void at insulation interface.
