## Long Beach July 2015 Secondary Network Outages RCE

### Summary and Report

## Summary of SCE's Performance Review of the Long Beach July 2015

### Secondary Network Outages

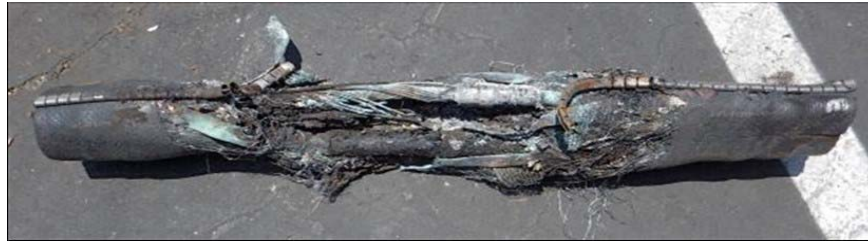
### ***The Failed Cable Splice***

SCE's internal investigation determined that the triggering event<sup>3</sup> that led to the July 15 power outage was the failure of a cable splice in an underground vault at Ocean Blvd. and Pacific Ave. in downtown Long Beach. A cable splice is where two segments of electrical wires are joined by utilizing high voltage cable components that are then reinsulated to form a continuous cable. An independent review of the damaged cable splice by engineering consultants was unable to determine the cause of the splice failure because there was too little material remaining at the splice connection to analyze.

The failure of that single cable splice resulted in a cascade of events on July 15 leading to circuits automatically shutting off, fires in three adjacent underground vaults and the eventual loss of power for at least some period of time to more than 30,000 customers. The outage on July 30 was caused by the failure of a cable that had been degraded by overloading during the July 15 event. This event was also followed by a series of circuit shutoffs and vault fires. Under normal conditions, these events should not have occurred following the cable splice failure on July 15.

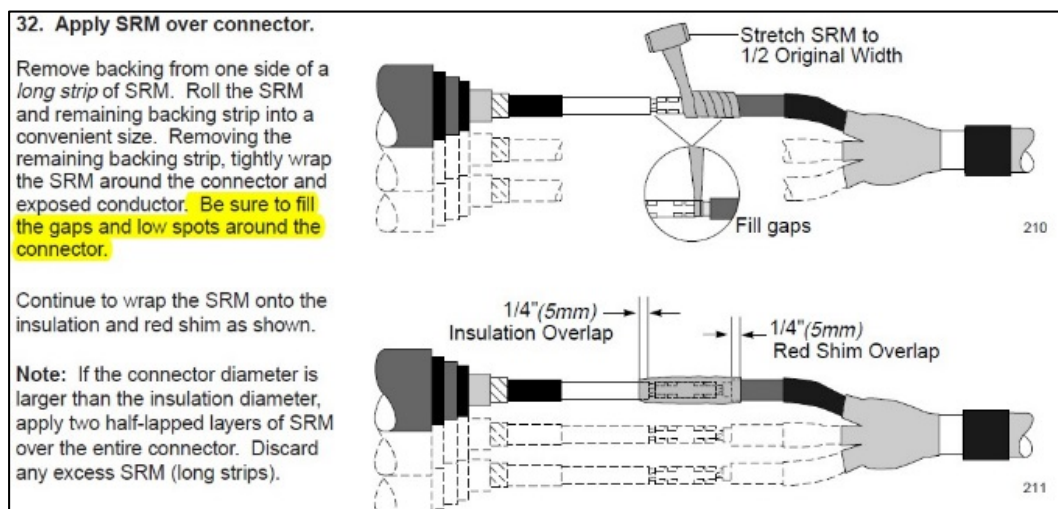
**Figure 3:** SRM application per manufacturers' instructions (IMCORP highlights)

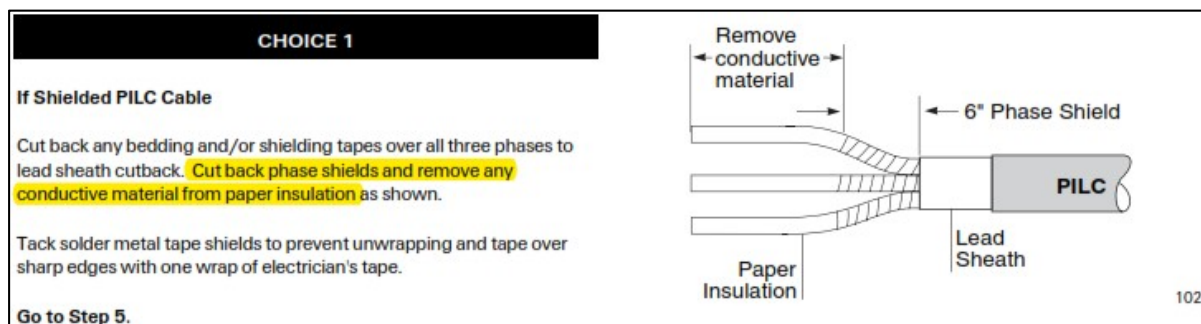
On the basis of the dissection observations, the single most significant risk factor to the premature failure of the sample labeled by SCE as "Steam" (Figure 1) is conductive material layer that was not removed from the joint and paper insulation interface as required by the manufacturer's installation instructions (Figures 5-8).

**Figure 6:** Dimensions of conductive material cutback per the manufacturers' instruction (step 7) (IMCORP highlight) Conductive materials including copper tape and black carbon paper tape must be removed to within 6 inches of the lead sheath.
